**Research Article****Modelling Fire Protection System Implementation in the Esa Hotel**

Study Location and Object in the research was conducted at Esa Hotel, a multi-storey hotel building located in Ponorogo, Indonesia. The object of the study was the implementation of fire protection systems, which include:

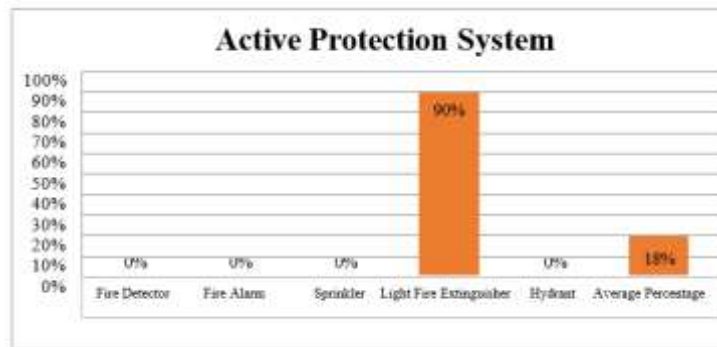
**Figure 2.** Active Protection System at the Esa Hotel

Based on the diagram above, there are observation results, the active protection system implemented at the esa hotel is only light fire extinguisher and other indicators have not been implemented. after observing the inspection criteria, the results of the study showed that the fire detector, fire alarm, sprinkler and hydrant indicators obtained a score of 0%, while light fire extinguisher obtained a score of 90% and an average percentage score of 18% was obtained.

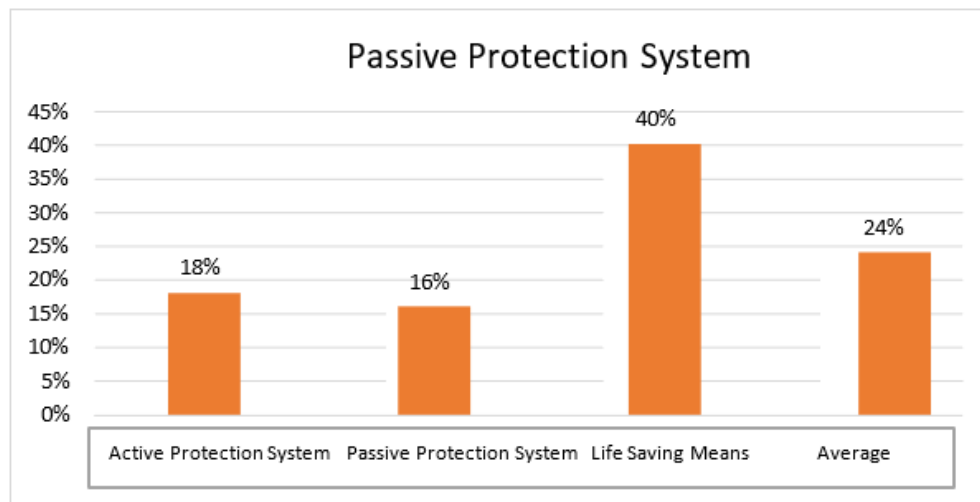
Figure 3. Passive Protection System at the Esa Hotel

In the diagram above, there are observation results, it is known that the fire protection system at the Esa Hotel. Procurement and installation of equipment that has not been implemented can be carried out according to the terms and conditions of each unit which are implemented according to the standards of the Regulation of the Minister of Public Works Number 26 of 2008 Concerning fire protection systems, namely fire detection systems.
